Case study Multi Seal Integrity

Diagnostics locate casing leak and help operator avoid costly workover to restore well

Location: Egypt, Western Desert
Well type: Gas producer

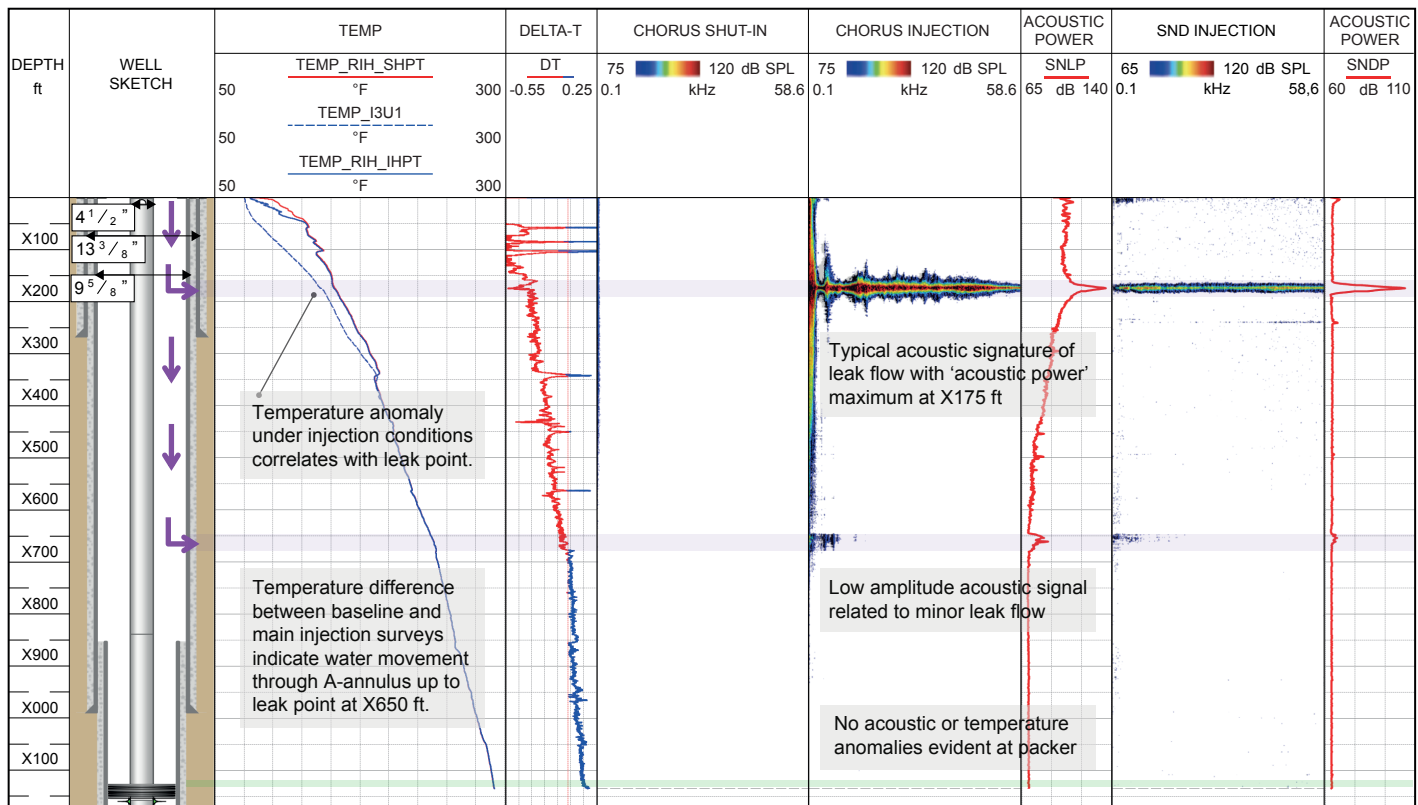
Notably, clear acoustic responses were evident at two intervals under injection conditions. A high amplitude wide frequency band acoustic signature, typical of 'leak flow' was observed at X175 ft. Also, a lower

amplitude, lower frequency signal was observed around X650 ft. No acoustic signal was observed across the upper packer confirming it was sealing properly.

The analyst confirmed the leak point in the 9-5/8" casing at X175 ft. The operator was able to assess the integrity of the well and decided not to remediate the casing leak, deciding instead to operate the well with the proper monitoring and risk mitigation plans in place.

Multi Seal Integrity answer product showing comparison between measurements acquired during shut-in and injection conditions. The primary leak point is clearly visible at X175 ft, and a minor leak interval is evident around X650 ft.
