Diagnosing conventional & alternative well barriers to enable rigless abandonment

Maxim Volkov, Principal Domain Champion, TGT

Mar 2021

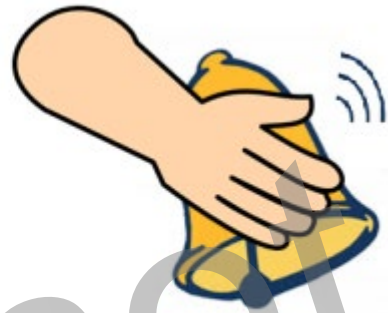
Low Attenuation

High Attenuation

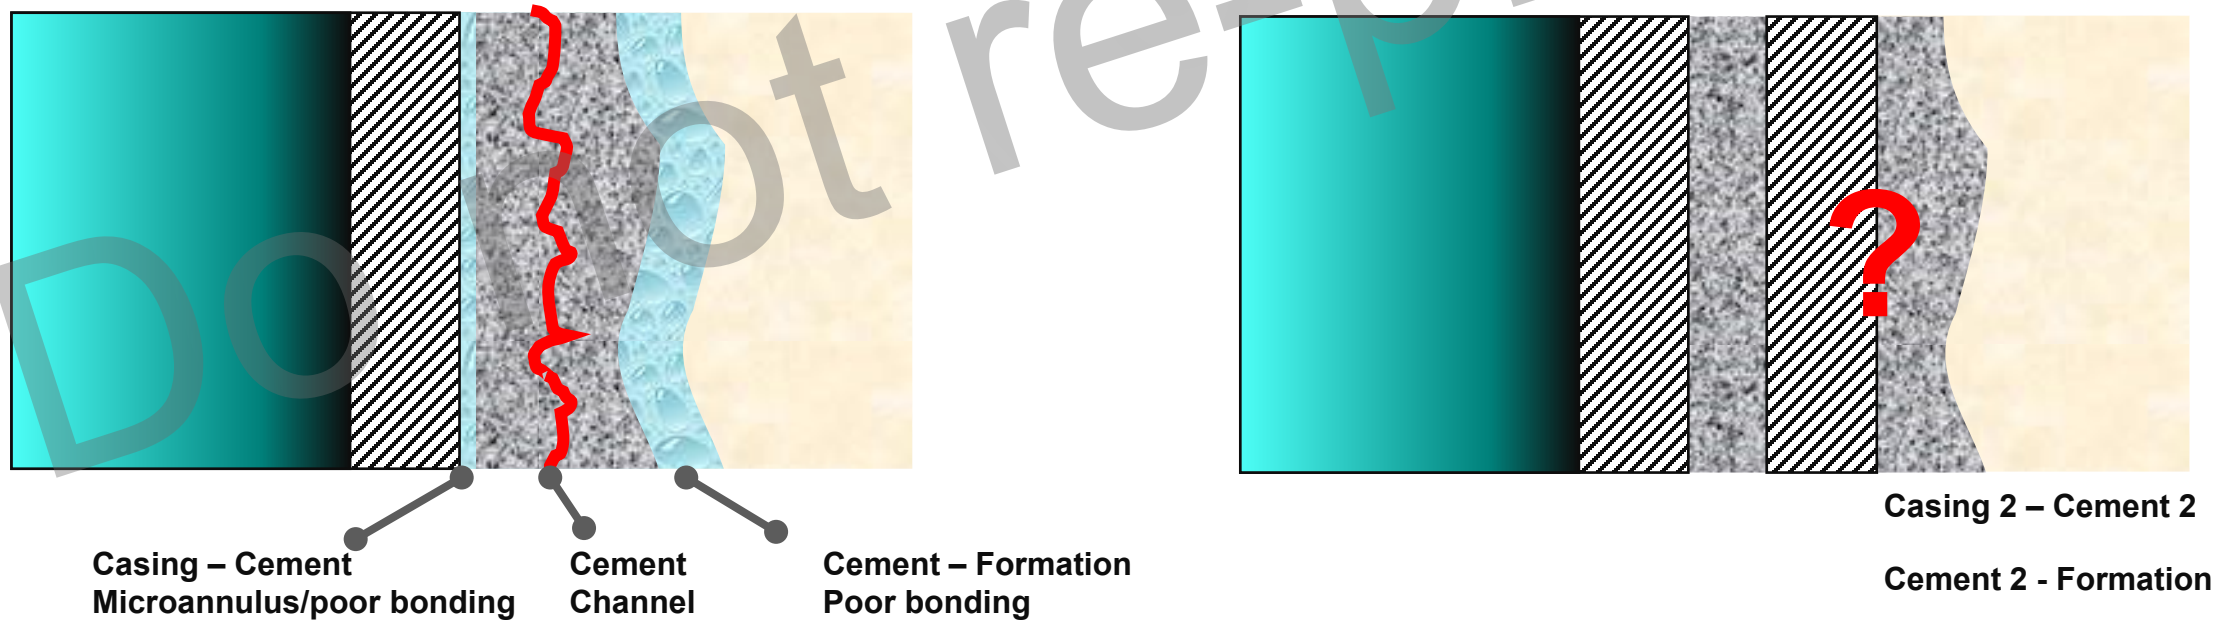
Plug & Abandonment - Cement Bond Evaluation

- Current evaluation techniques assess casing to cement bond mainly
- Minimum detectable channel in cement approx. 1"
- Limited assessment of cement to formation bond
- Cement map is affected by casing/wellbore condition
- Single casing only

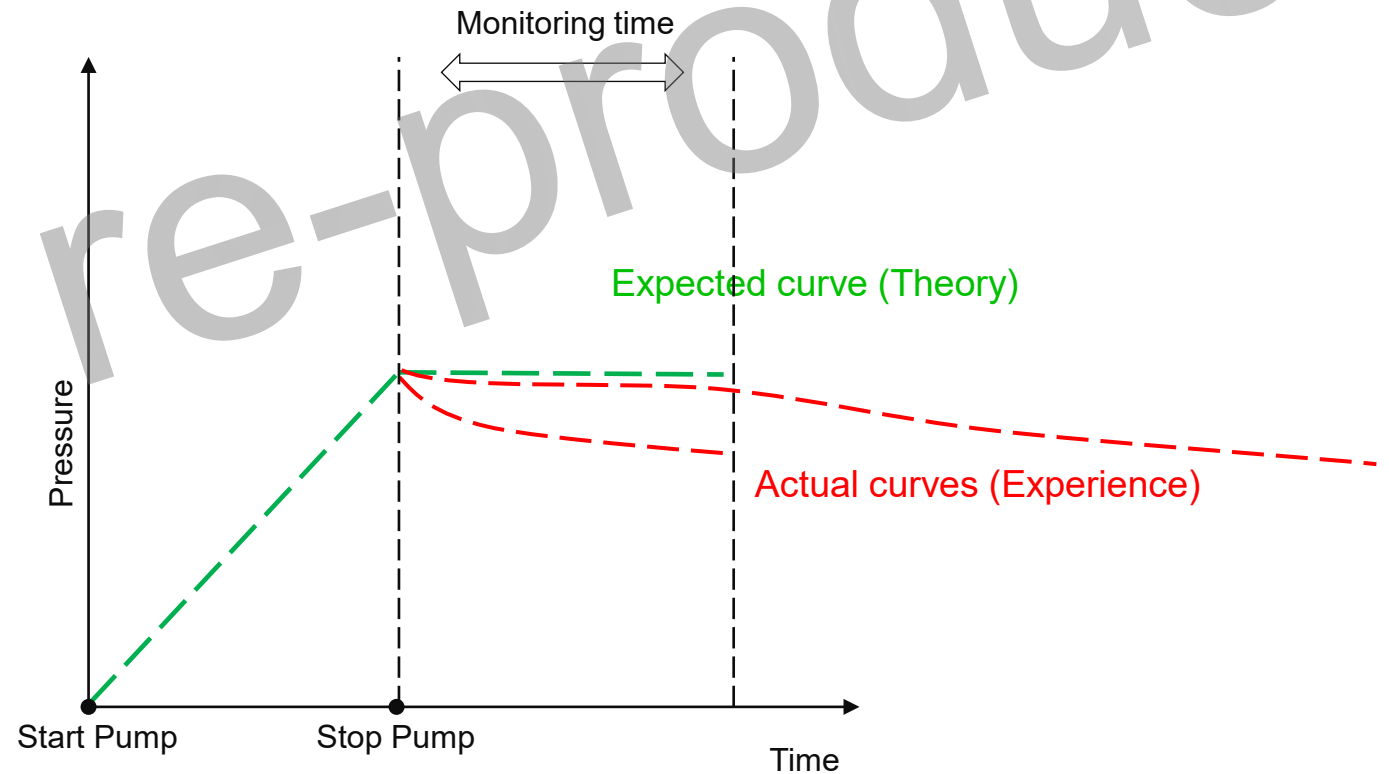
Plug & Abandonment - Pressure Test Technique.

- Casing(s) ballooning
- Leaks into non-targeted zones
- Missed minor leaks
- Short monitoring time

Interpreting a test result

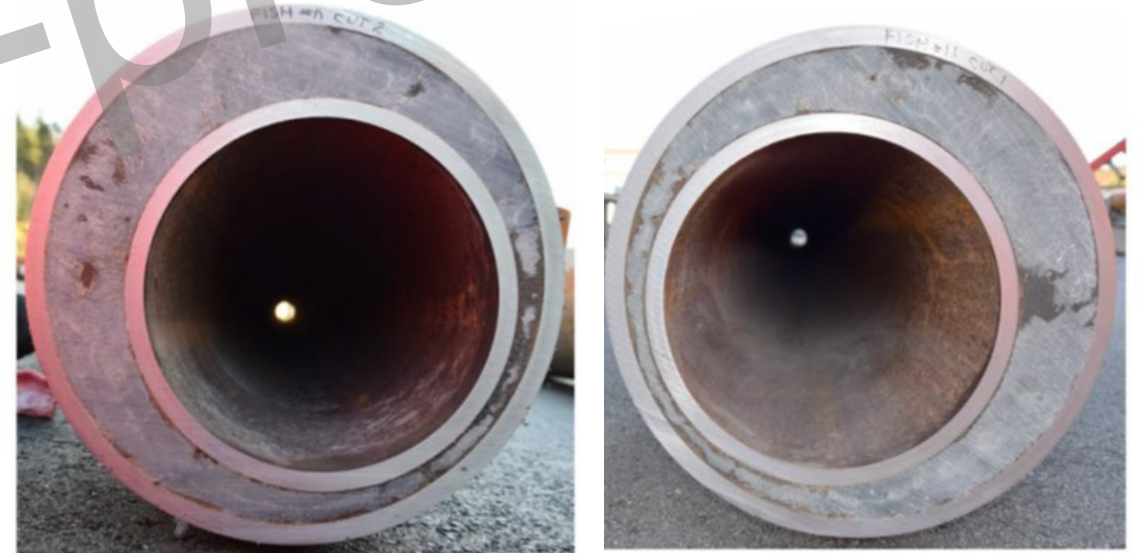
Norce test 2019

Barrier Verification during Plug and Abandonment Using Spectral Noise Logging Technology, Reference Cells Yard Test

- The resolution of Chorus technology was investigated over a range of leakage rates of water and gas for different casing cement sheath defects
- For the conditions tested, leakage was detected for rates of water and gas lower than the accepted criteria defined by API RP14B
- Where differential pressure is present across a well barrier, passive acoustics can be used to detect whether flow generated acoustic signatures are present

Reference cell	Rate threshold	
	Water	Gas
Micro-annulus (56 microns)	80 mL/min	1.2 mL/min
Good cement (induced microannulus)	9.7 mL/min	N/A
5mm channel	300 mL/min	11 L/min
API 14B	400 mL/min	420 L/min

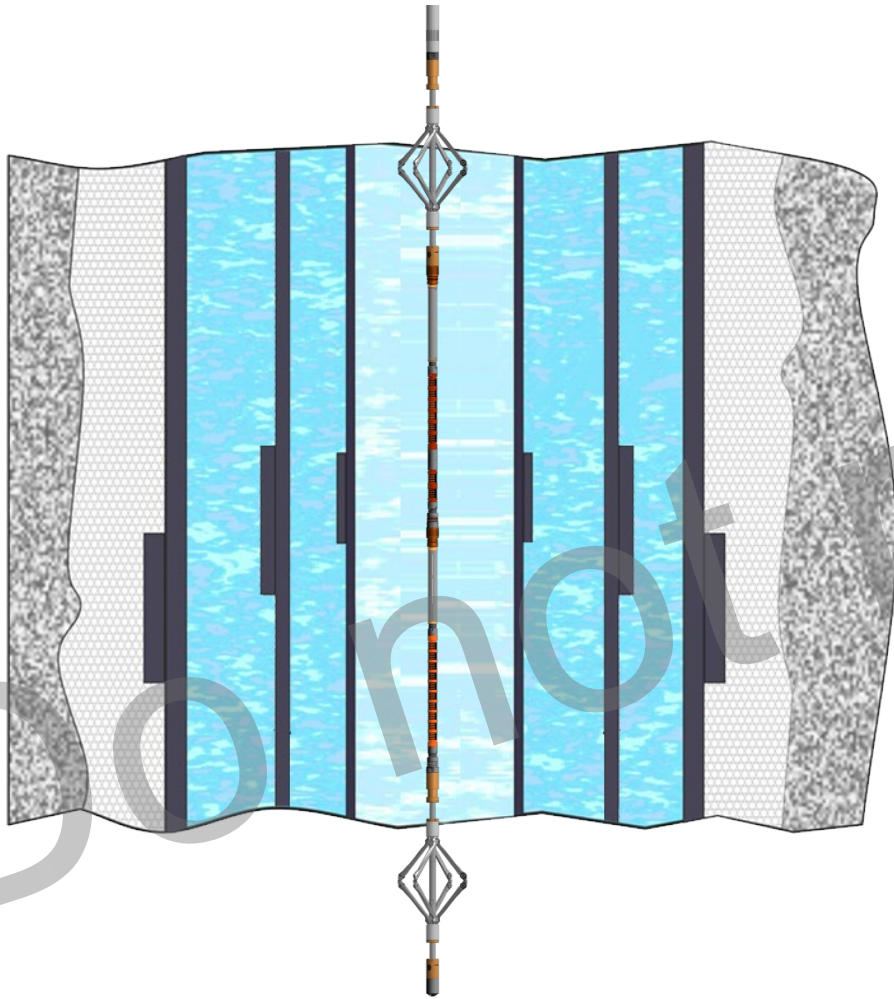
Tube Integrity Diagnostics - Pulse

- Sensitive to the metal only – free from scale influence .
- No requirement for the well to be shut-in.
- Internal / external corrosion assessment for the primary tube.
- Location of tubing to casing decentralization (severe).
- Location of completion jewelry in first 4 casing strings.

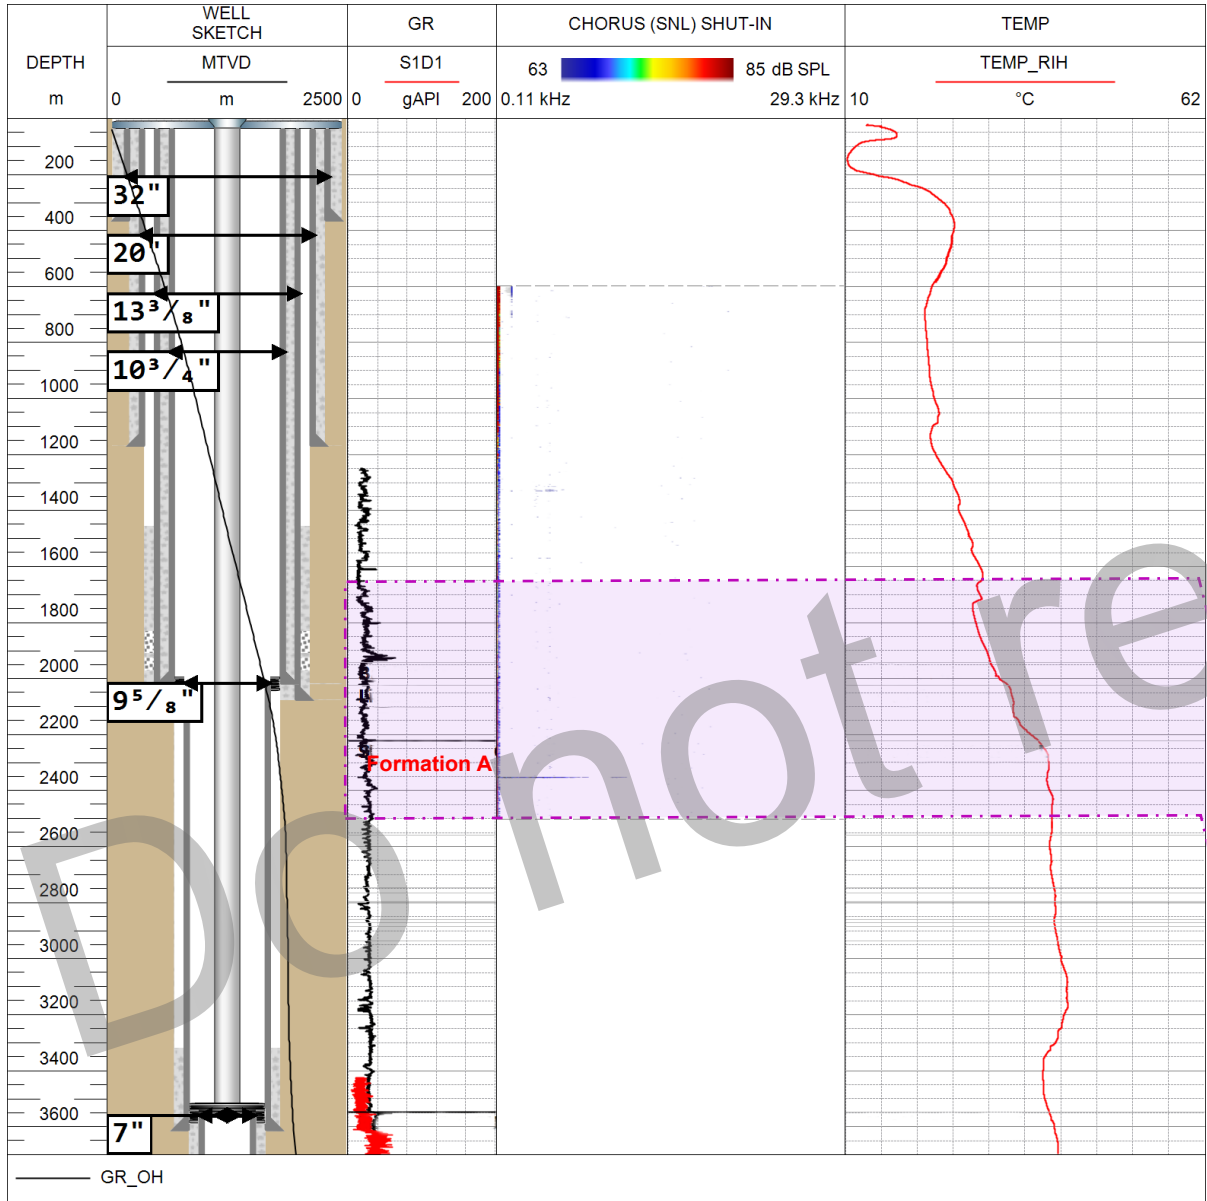
Verifying the Cement Barrier Through Tubing

Cement /
Shale creep
sealing
failure

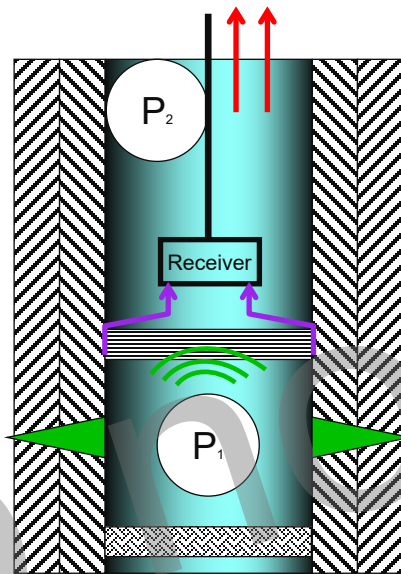
Perf and pressure test (Leak off test)

Testing BHA

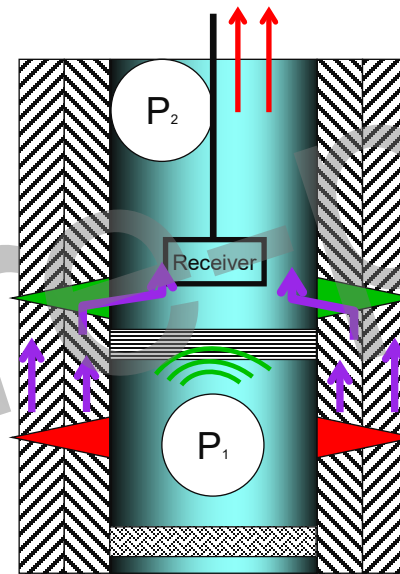
Testing communication
Bottom to middle perf

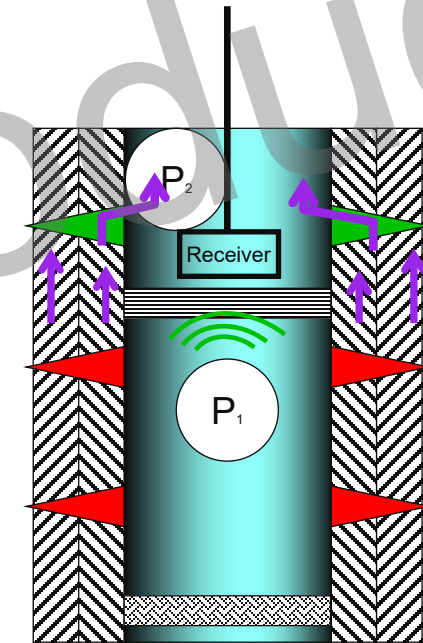
Testing communication
Middle to top perf

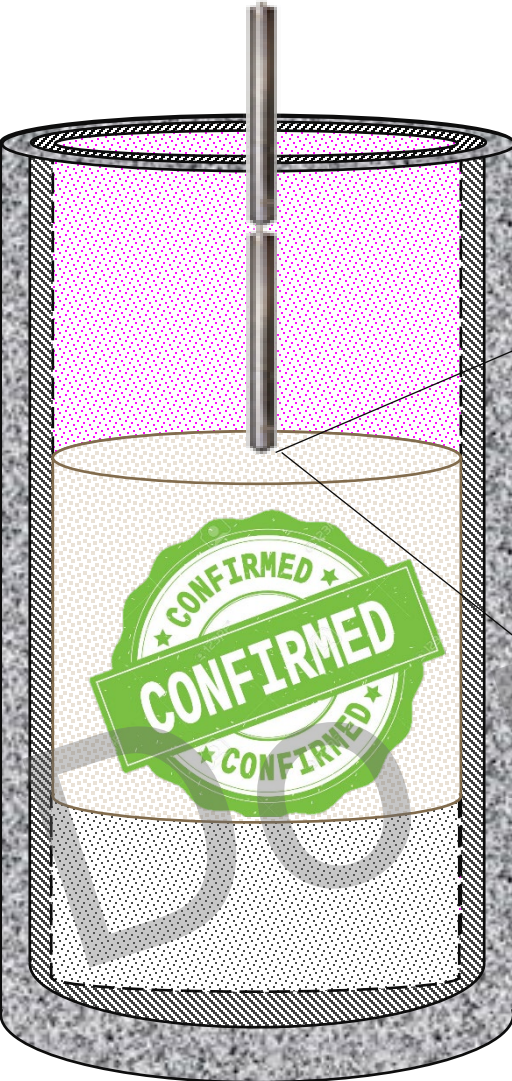
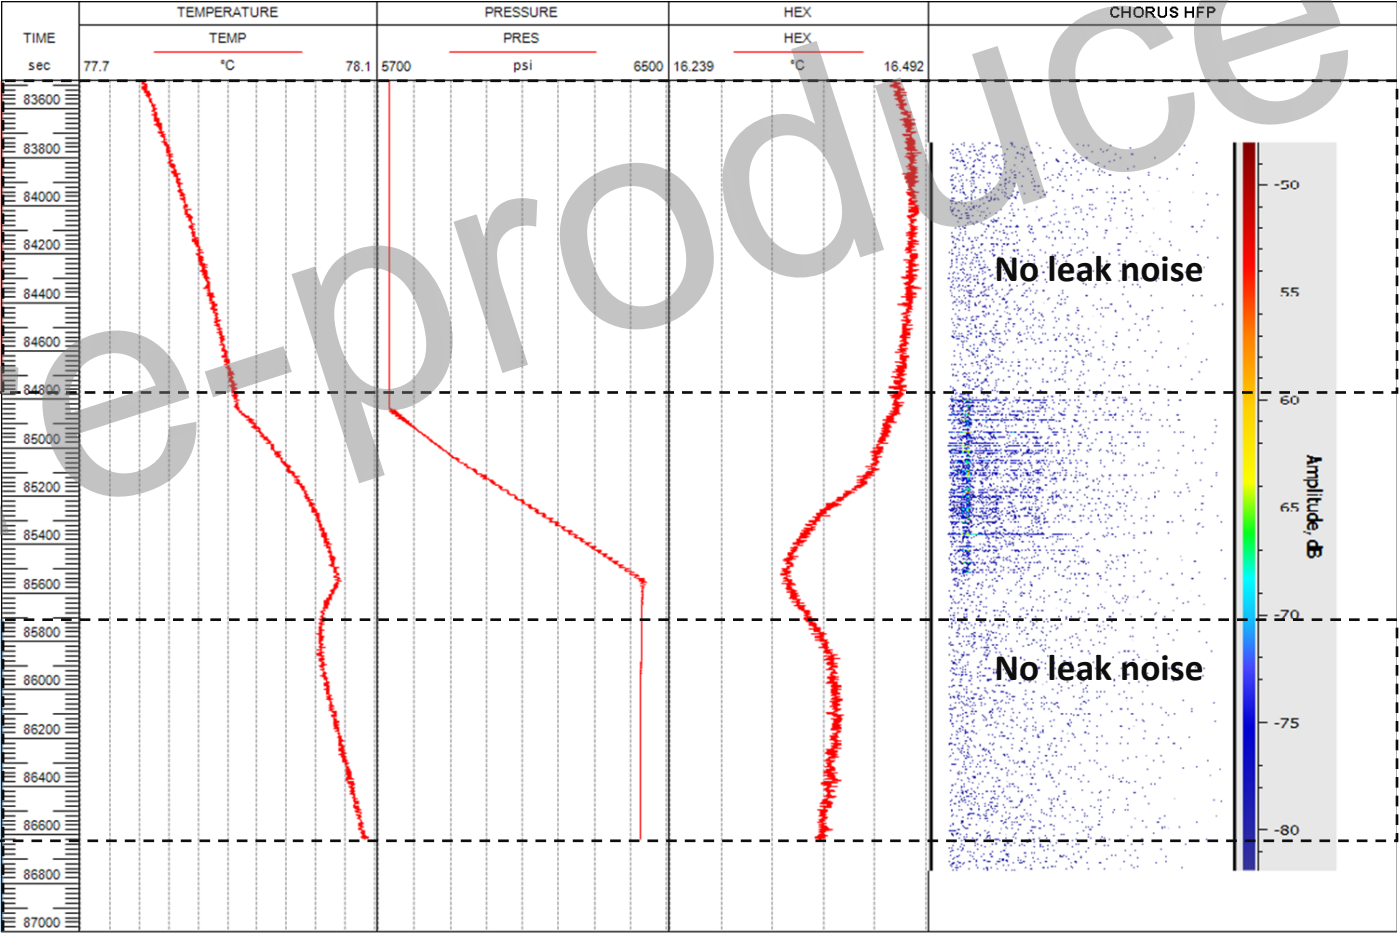
Cement Plug Pressure Test (success)

Shut-in Station
(5 minutes)

Pressure Test Station
(30 minutes)
