Case study Drilling Losses

Lost-circulation zones identified from inside drill pipe, enabling quick remediation

Case study Drilling Losses CS001

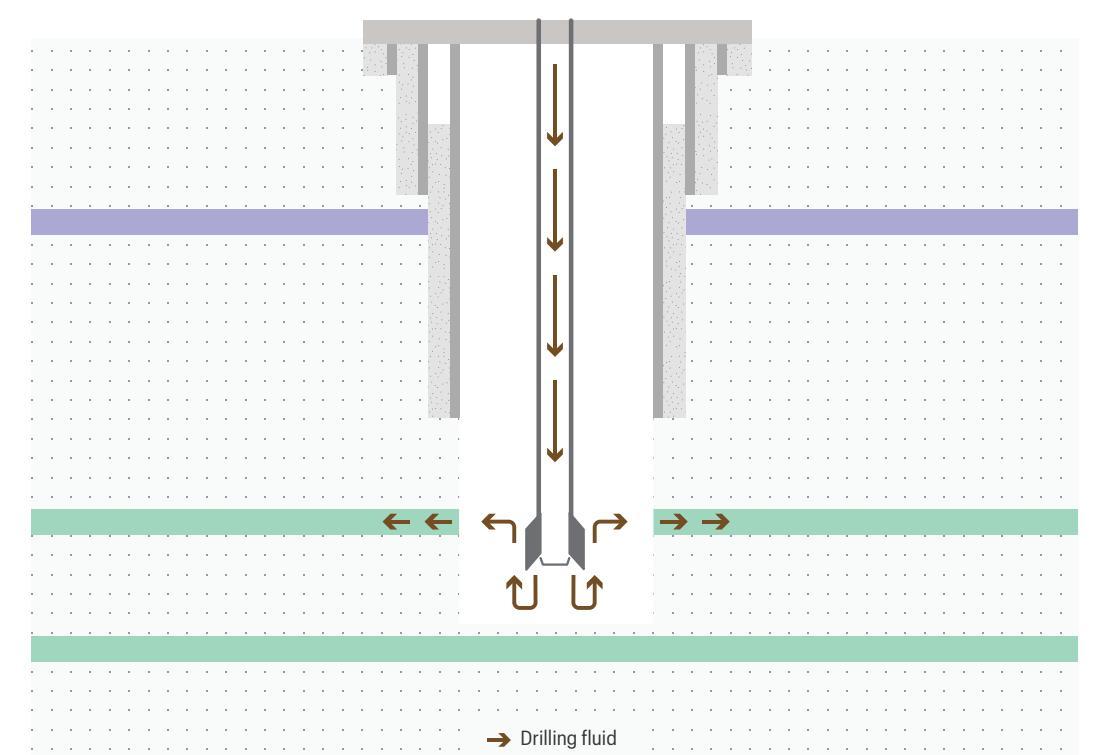
Drilling Losses example well sketch.

Drilling Losses pinpoints lost circulation zones rapidly and accurately, without pulling the drill string.
